Initially drafted diagram of DAST engine.

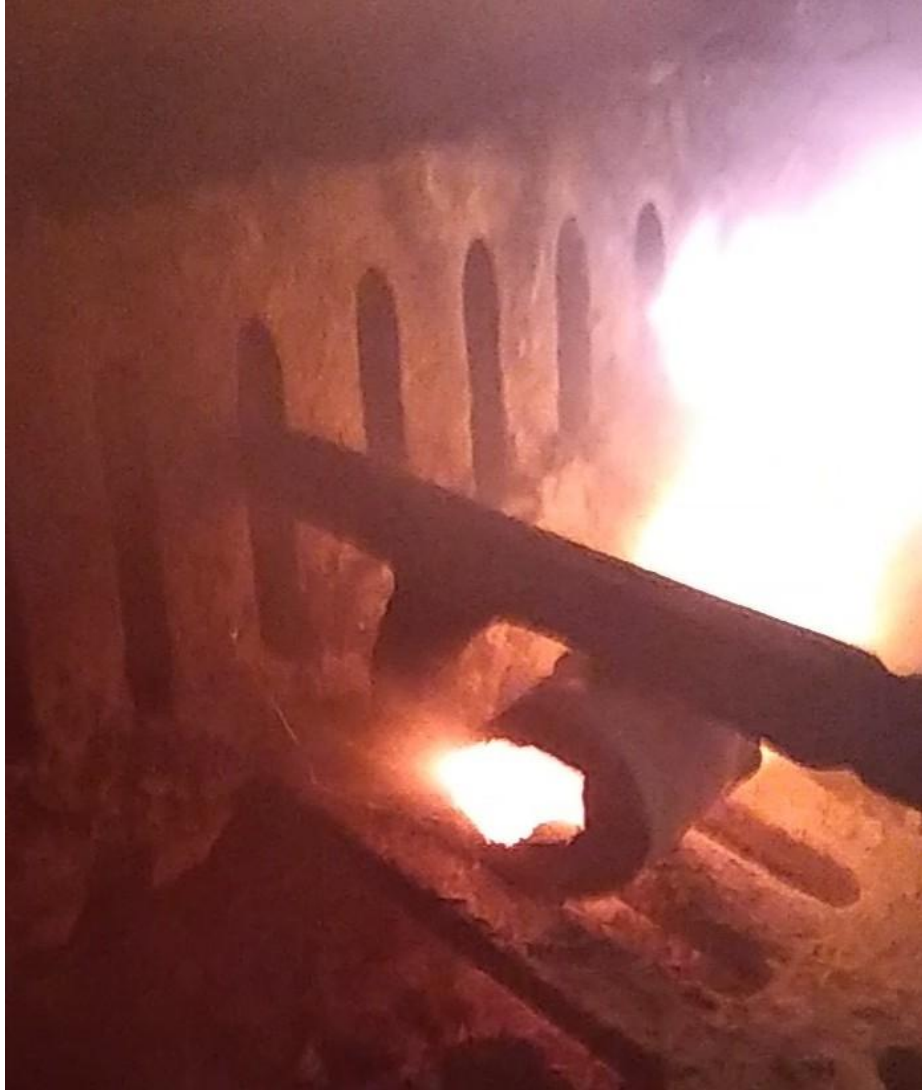
Preliminary test assessing the effects of airflow on weakly-oxidized combustion.

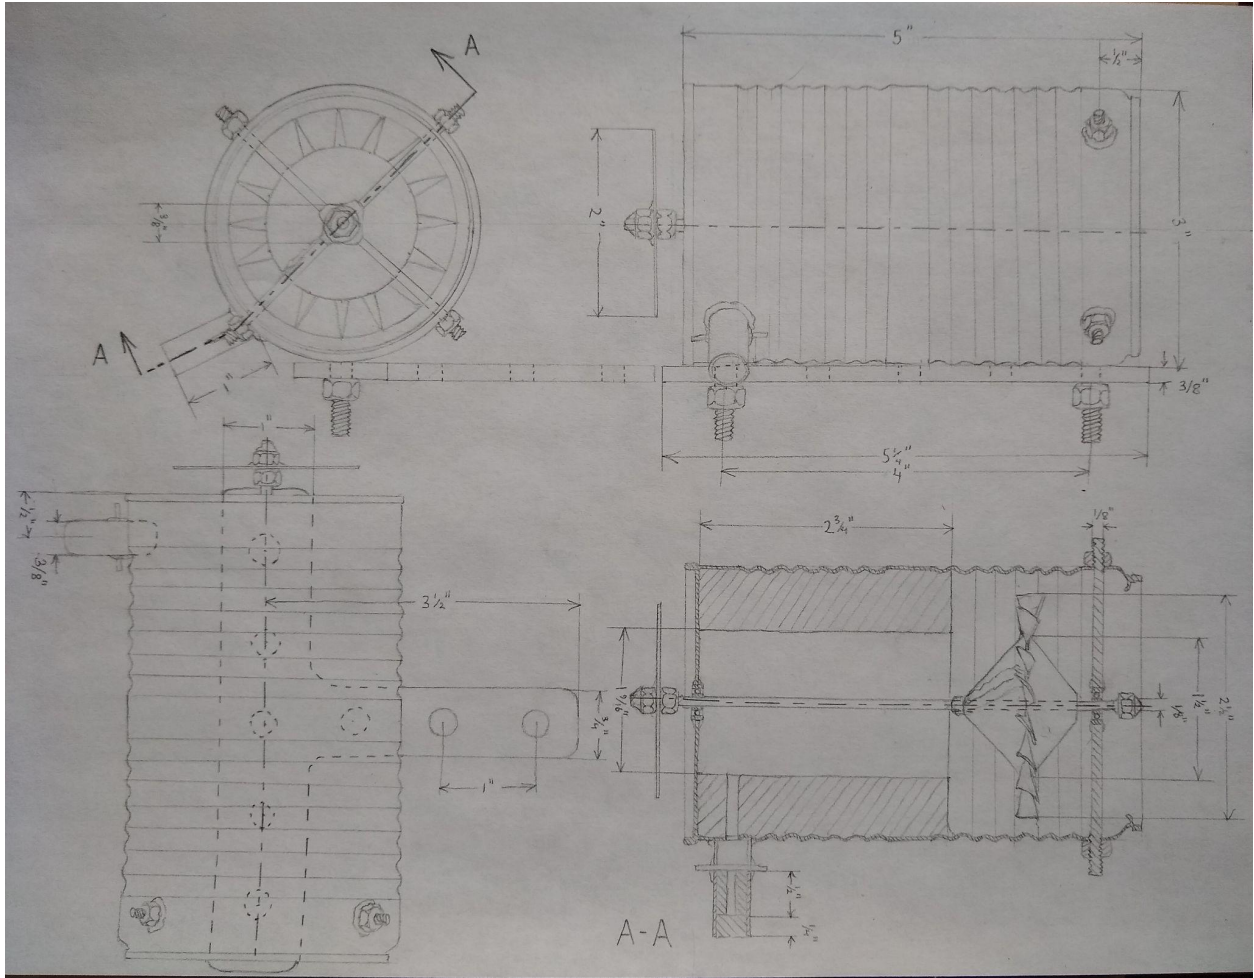
Orthographic diagram of Prototype 1, as it was tested. (Not used in construction)

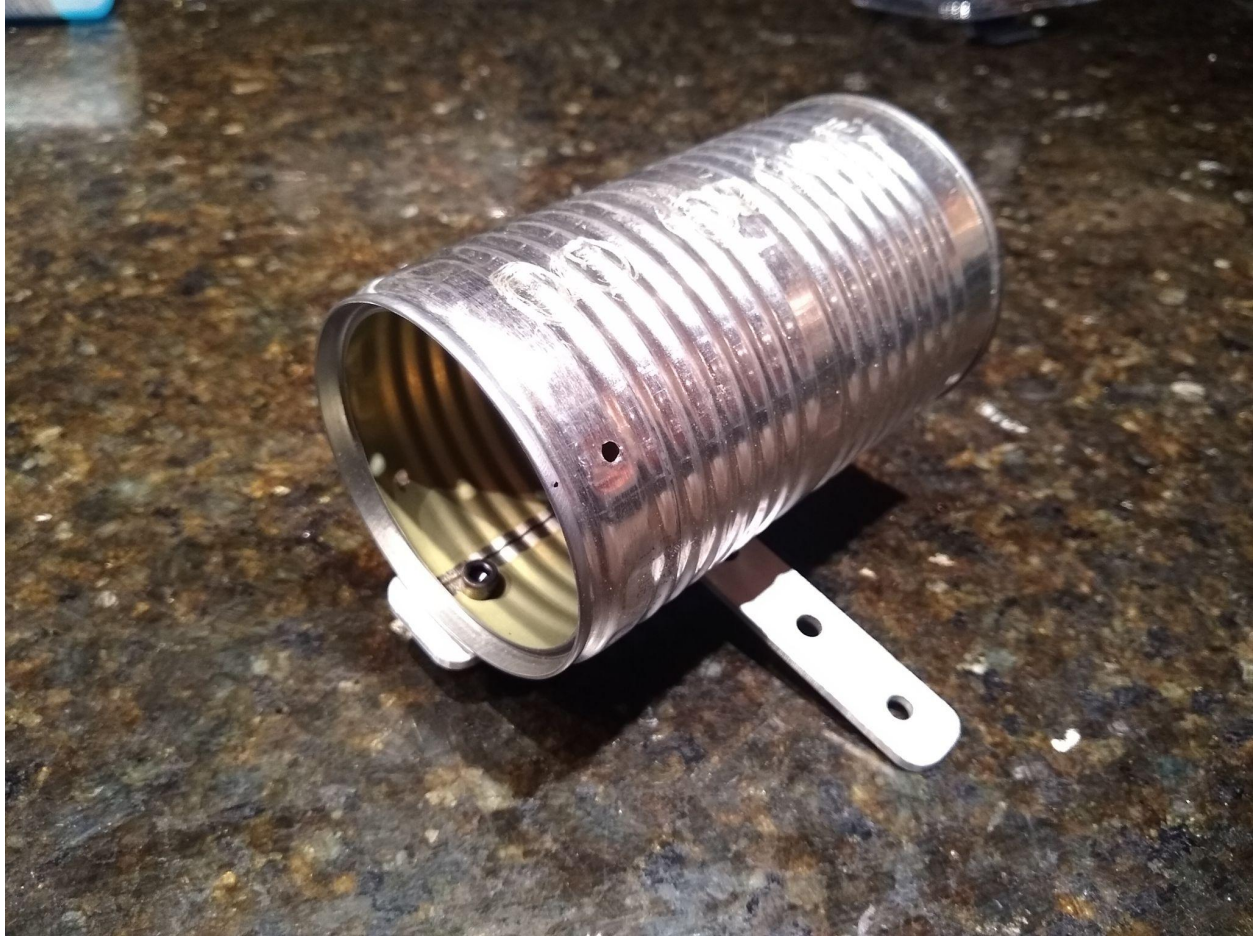
Prototype 1 engine casing with bracket bolted into place.

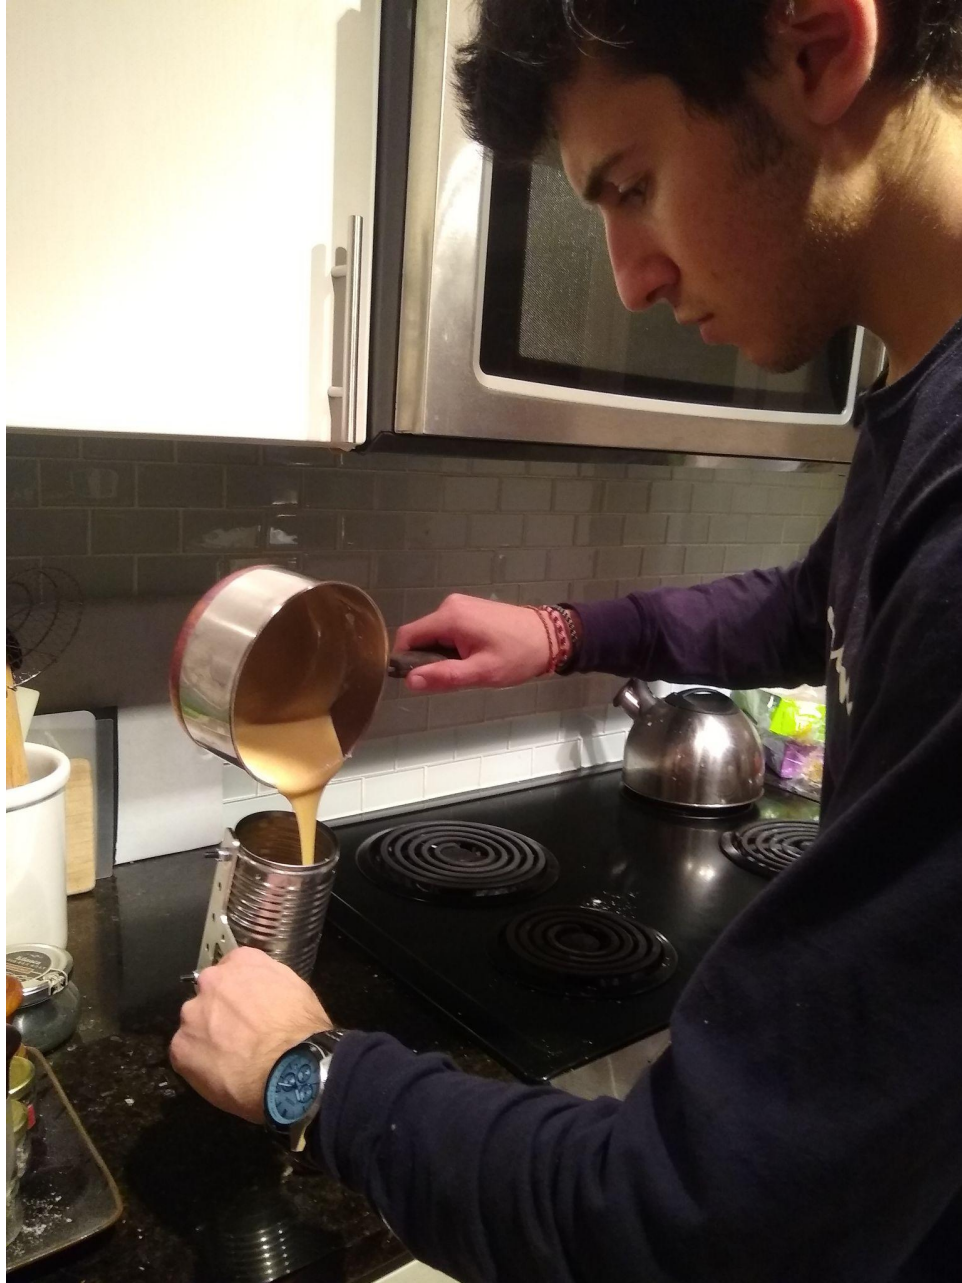
Pouring melted fuel into engine casing during the process of casting the fuel grain.

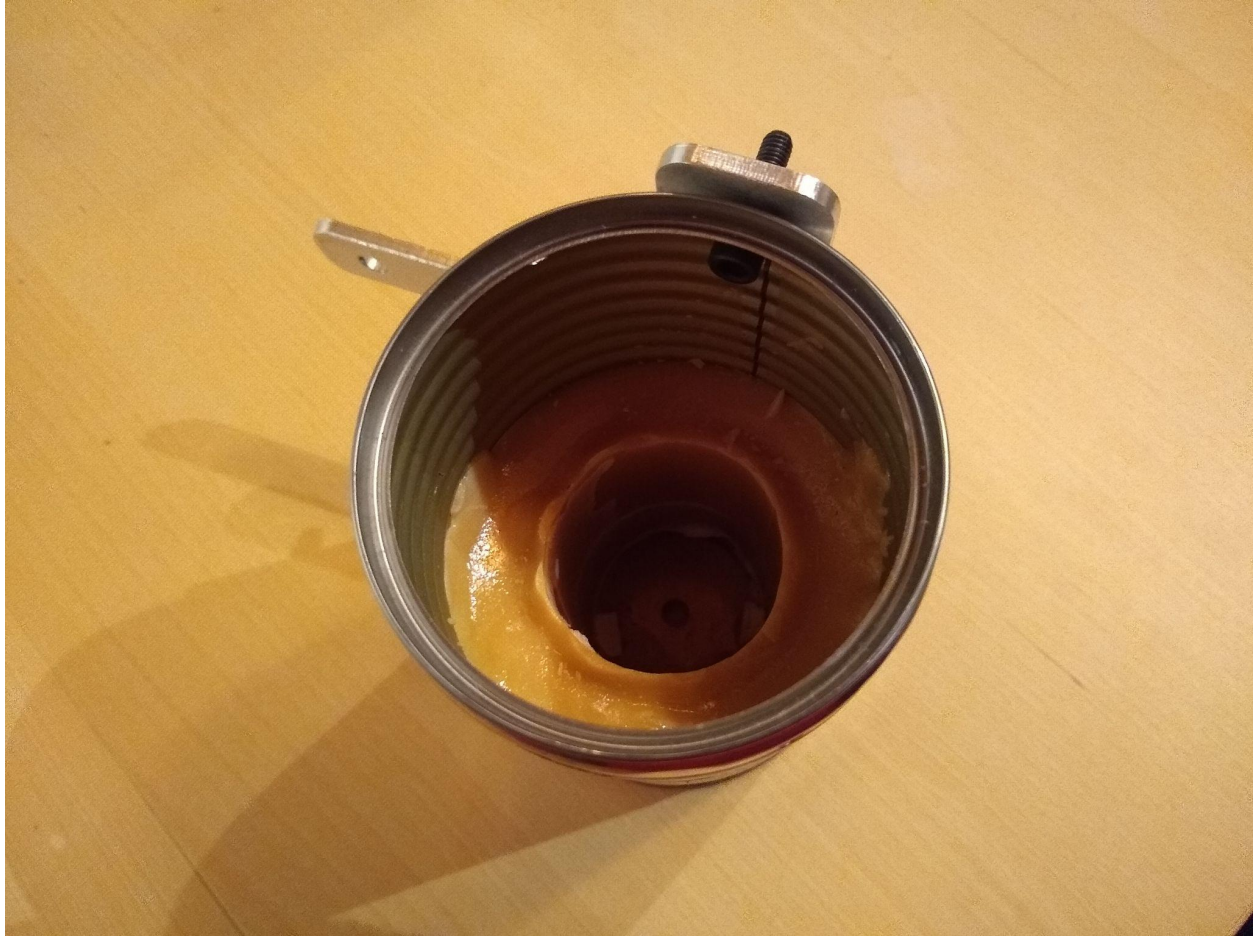
Solidified fuel grain with paper mold removed.

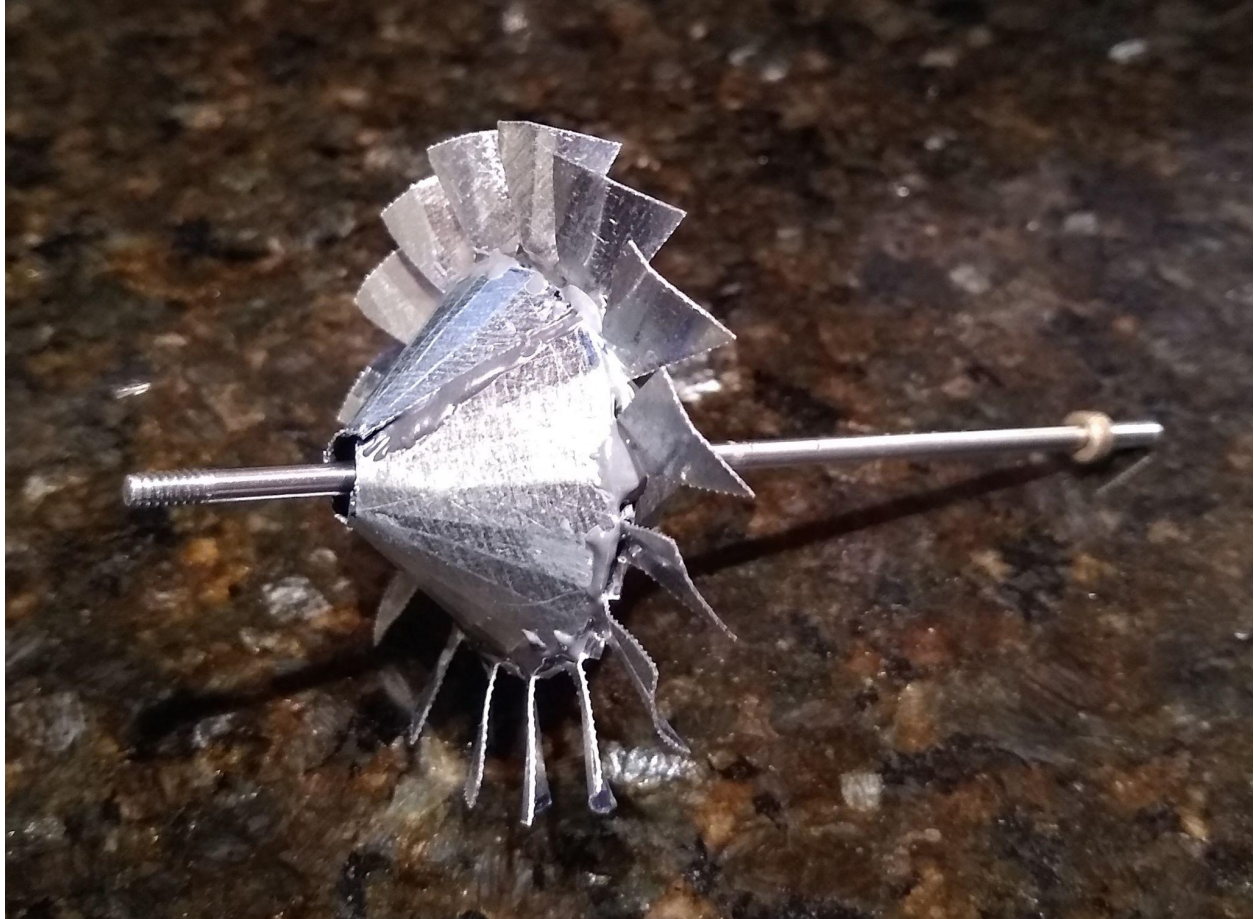
Turboshaft assembly before insertion into the engine.

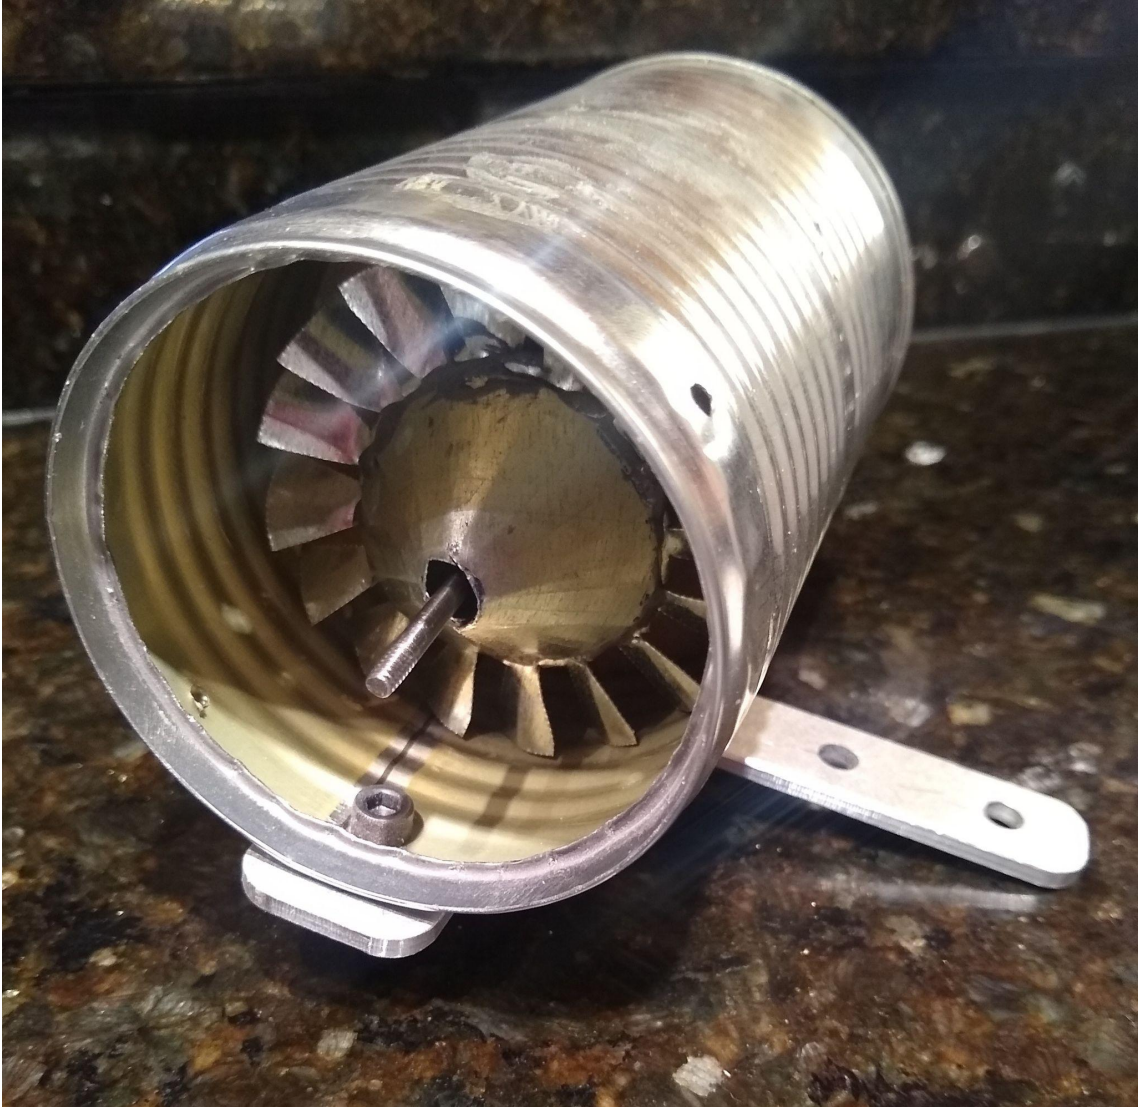
Engine casing and turboshaft assembly viewed together before permanent mounting.

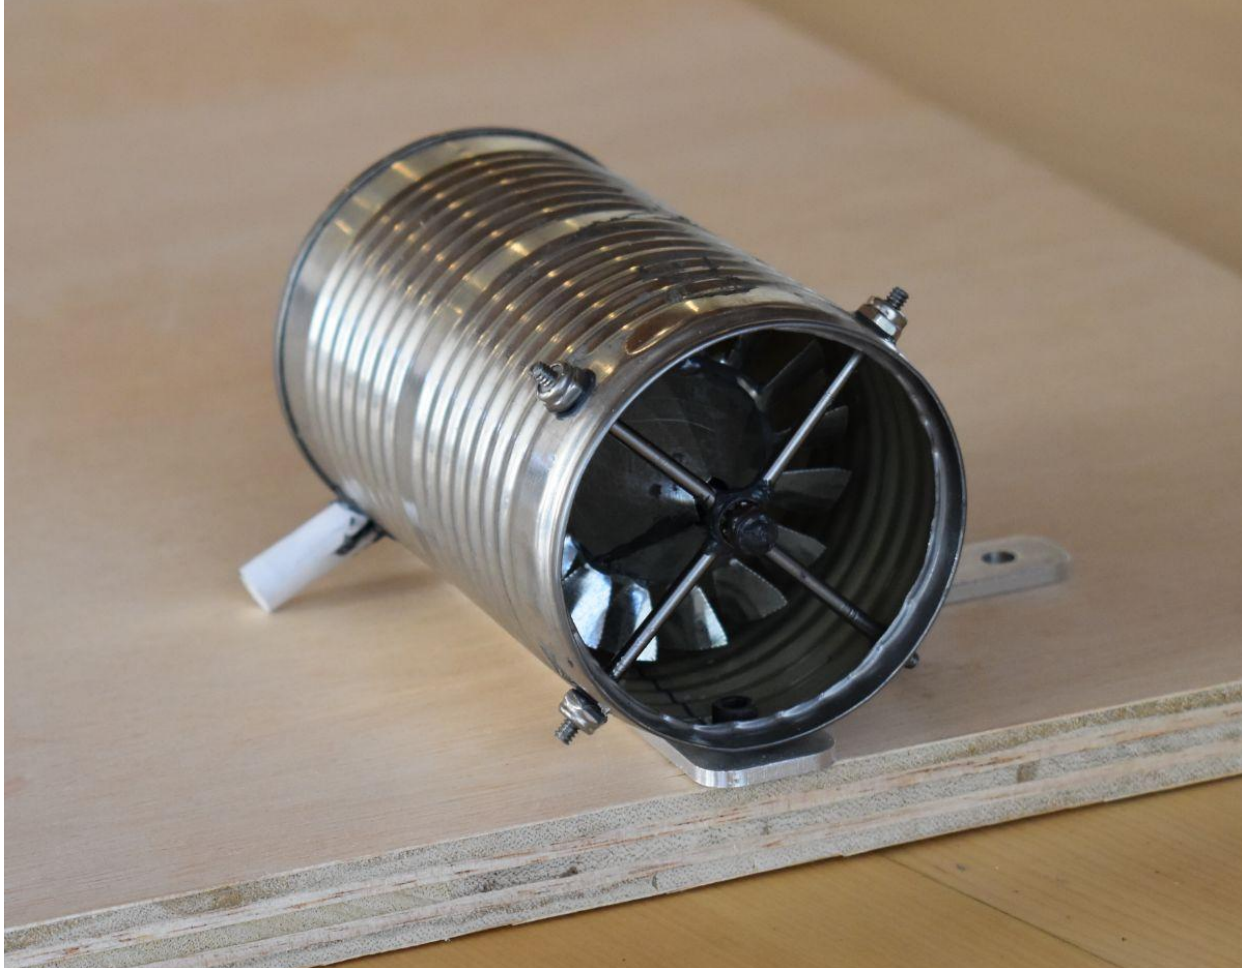
Rear left view of completed Prototype 1 mounted on testing base.

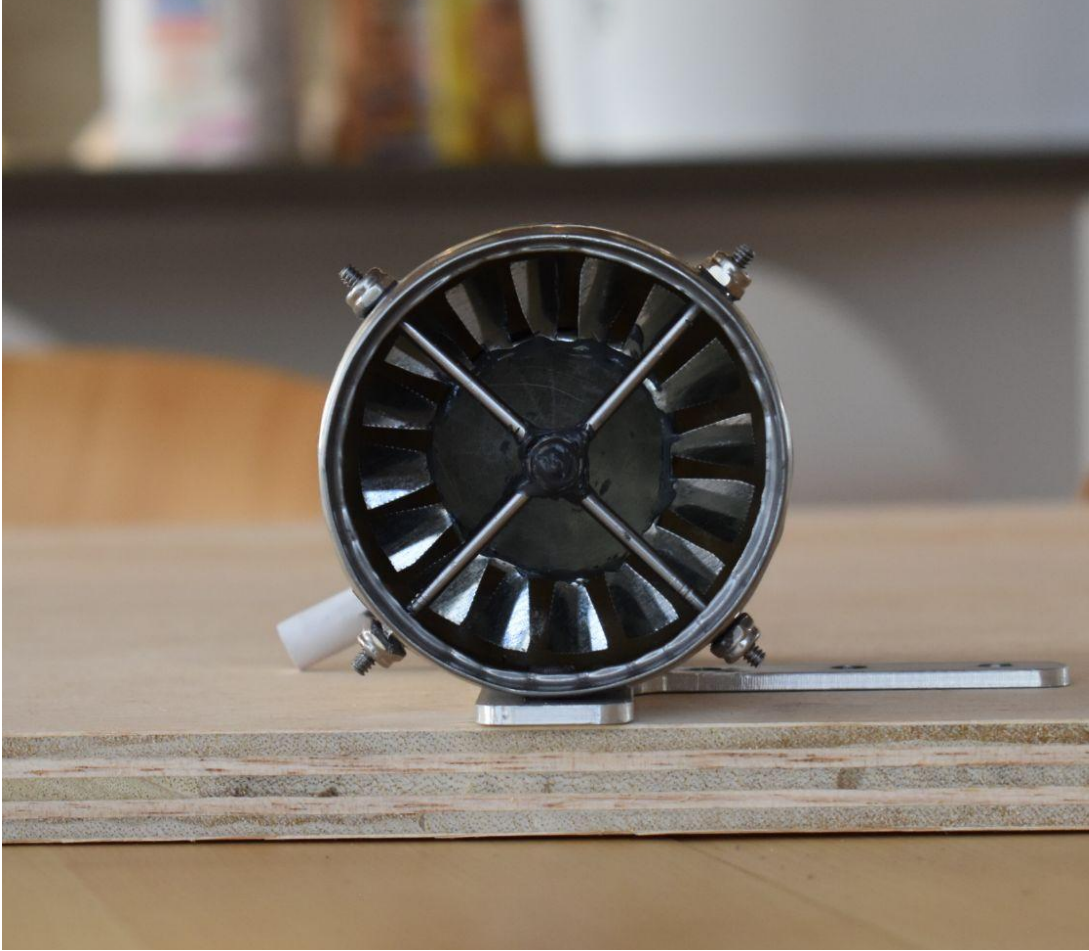
Rear internal view of Prototype 1 mounted on testing base

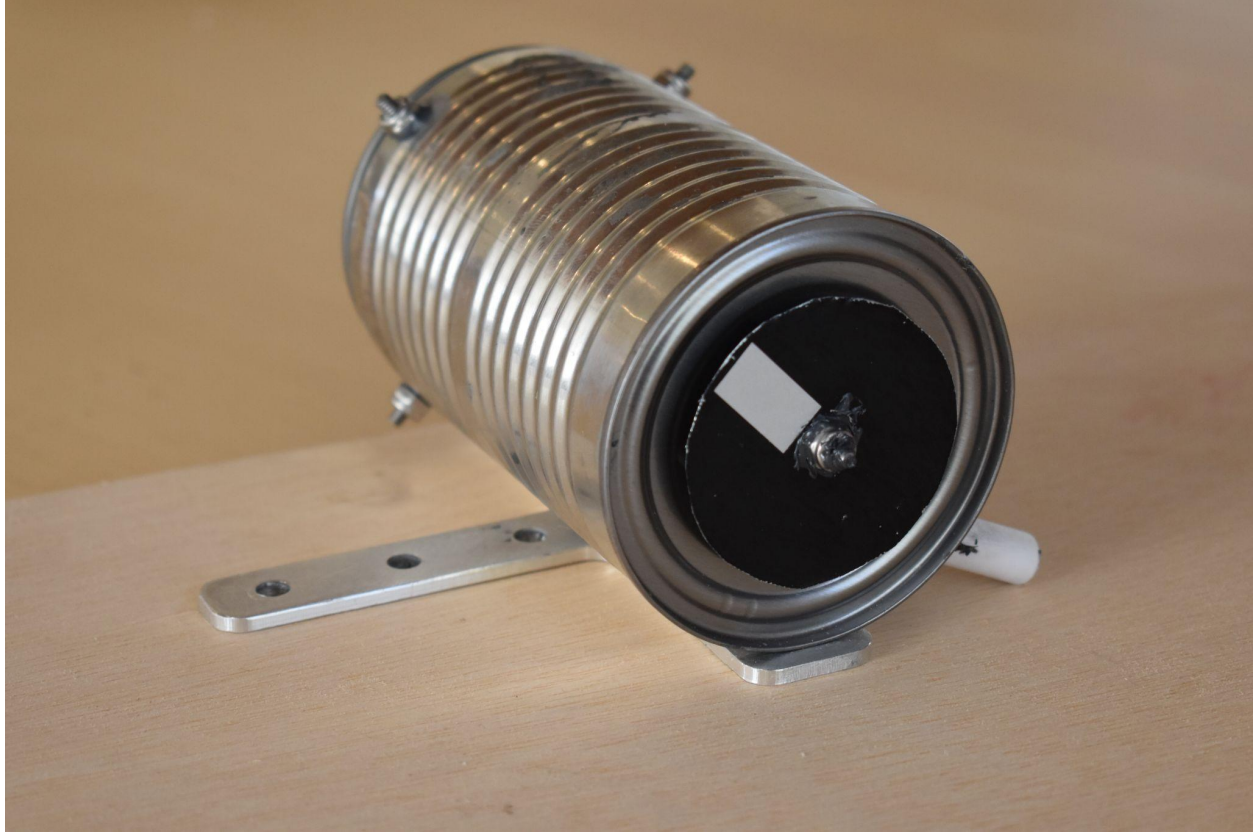
Front left view of Prototype 1 (and reflector disk) mounted on testing base.

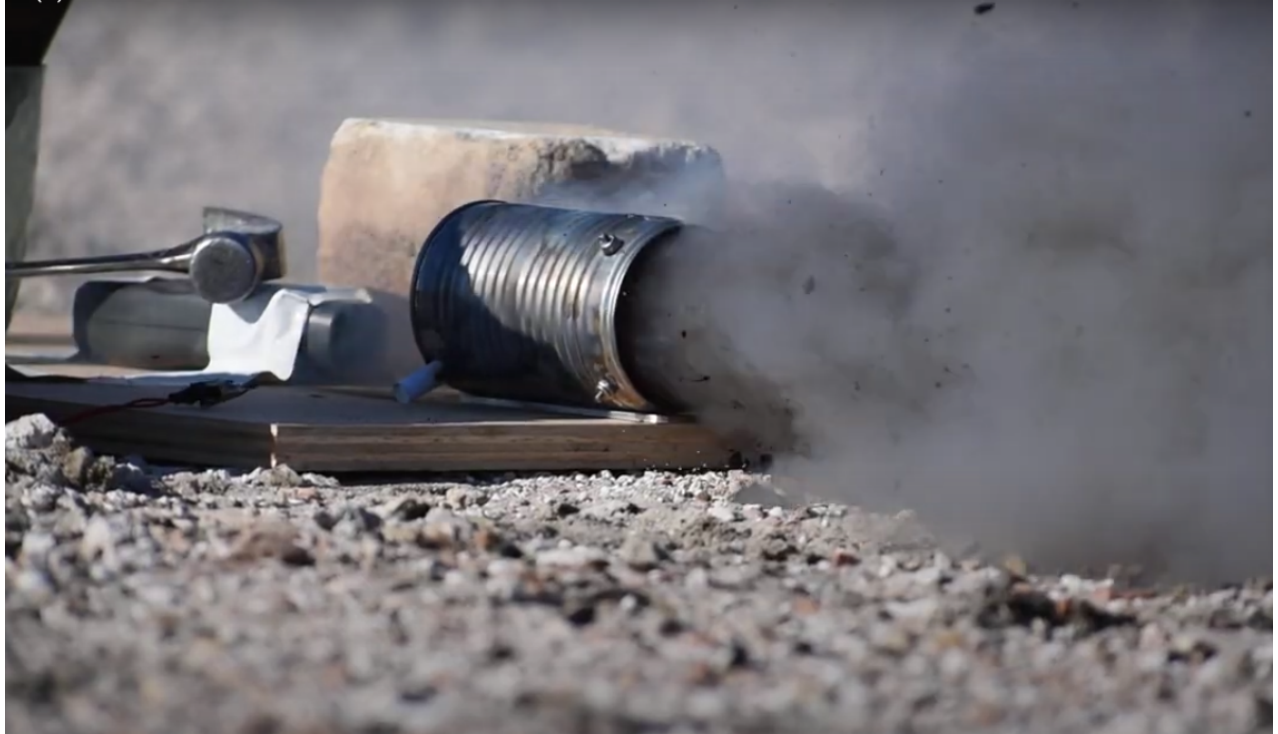
Still shot of Prototype 1 during testing.

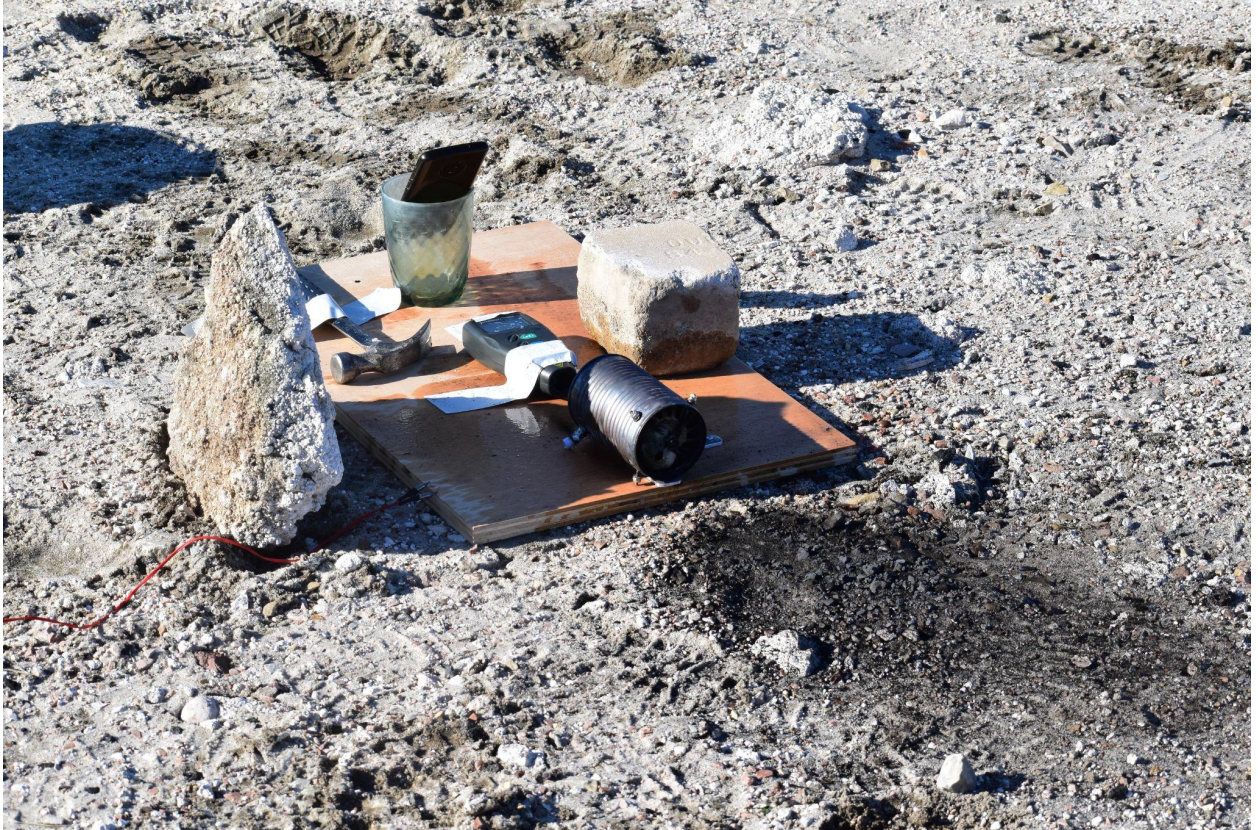
Experimental setup of equipment following the test of Prototype 1.

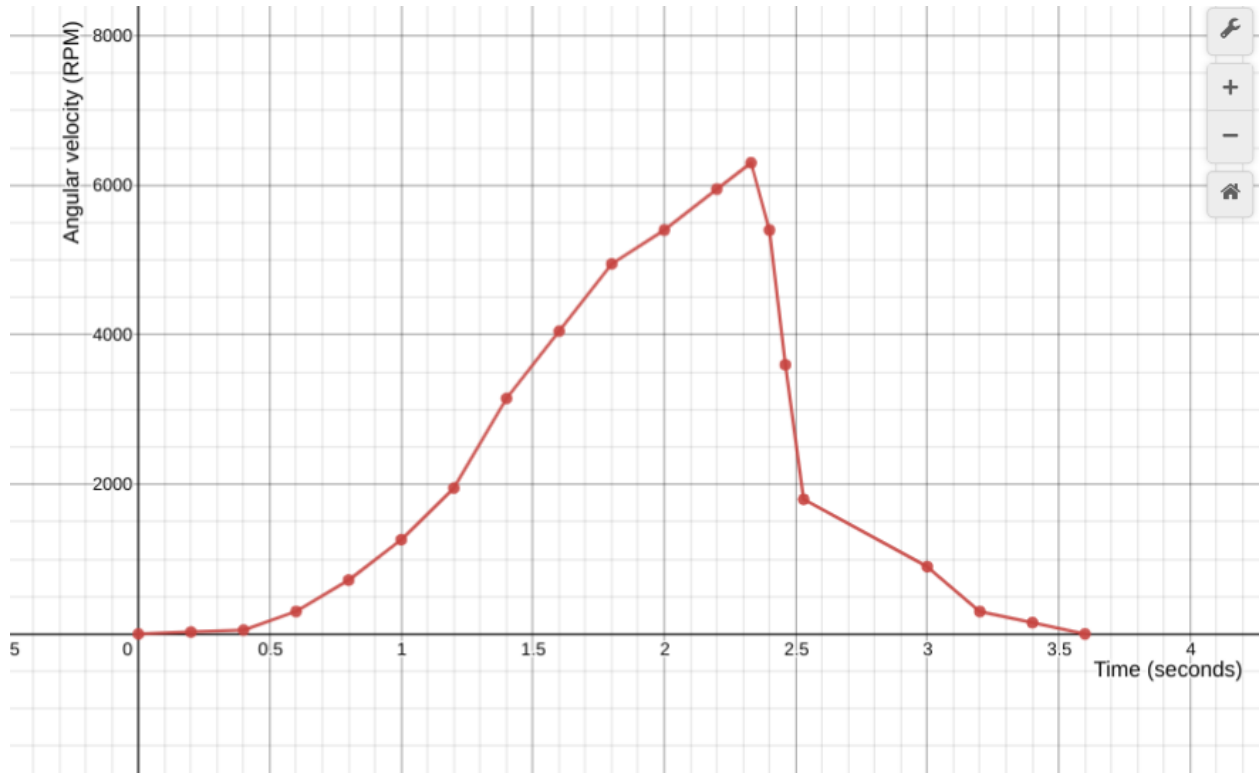
Collected and graphed data of turboshaft angular velocity over time.

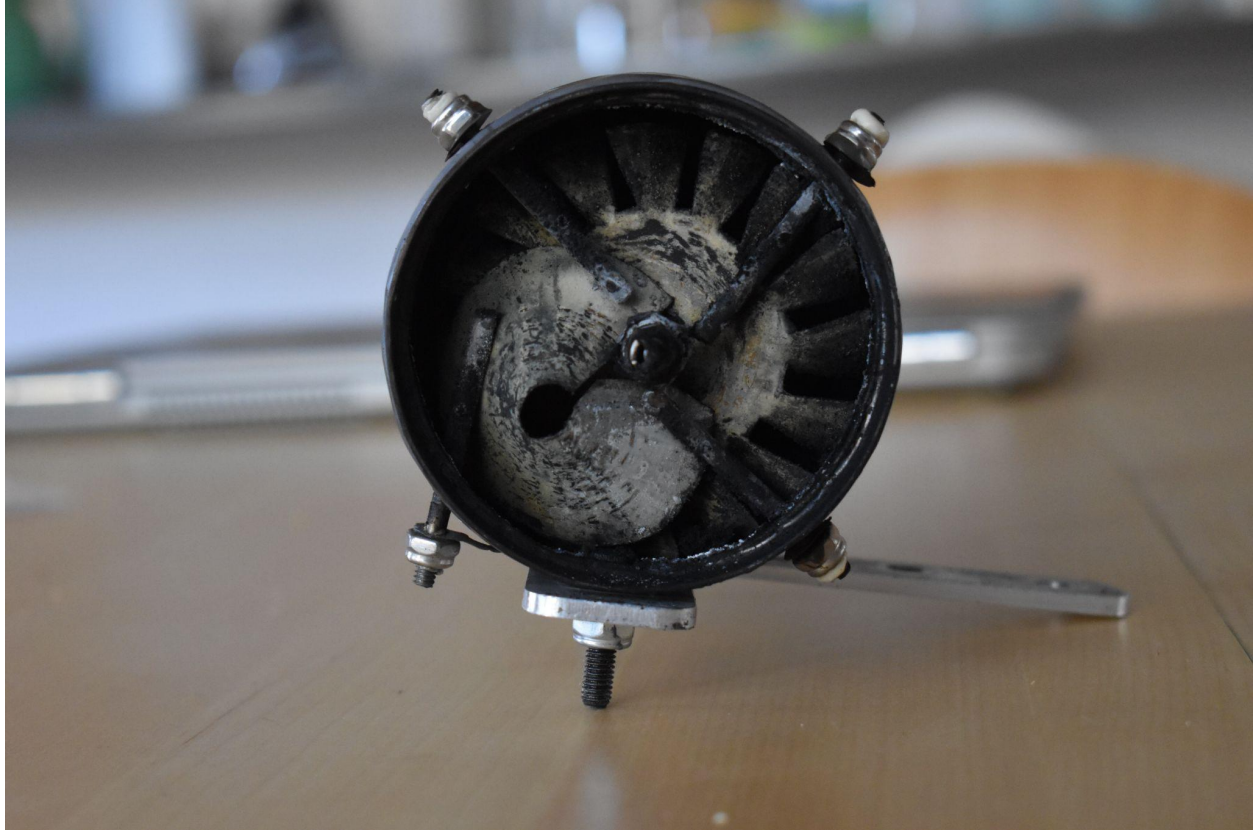
Rear view of Prototype 1 and damaged internal components following testing.

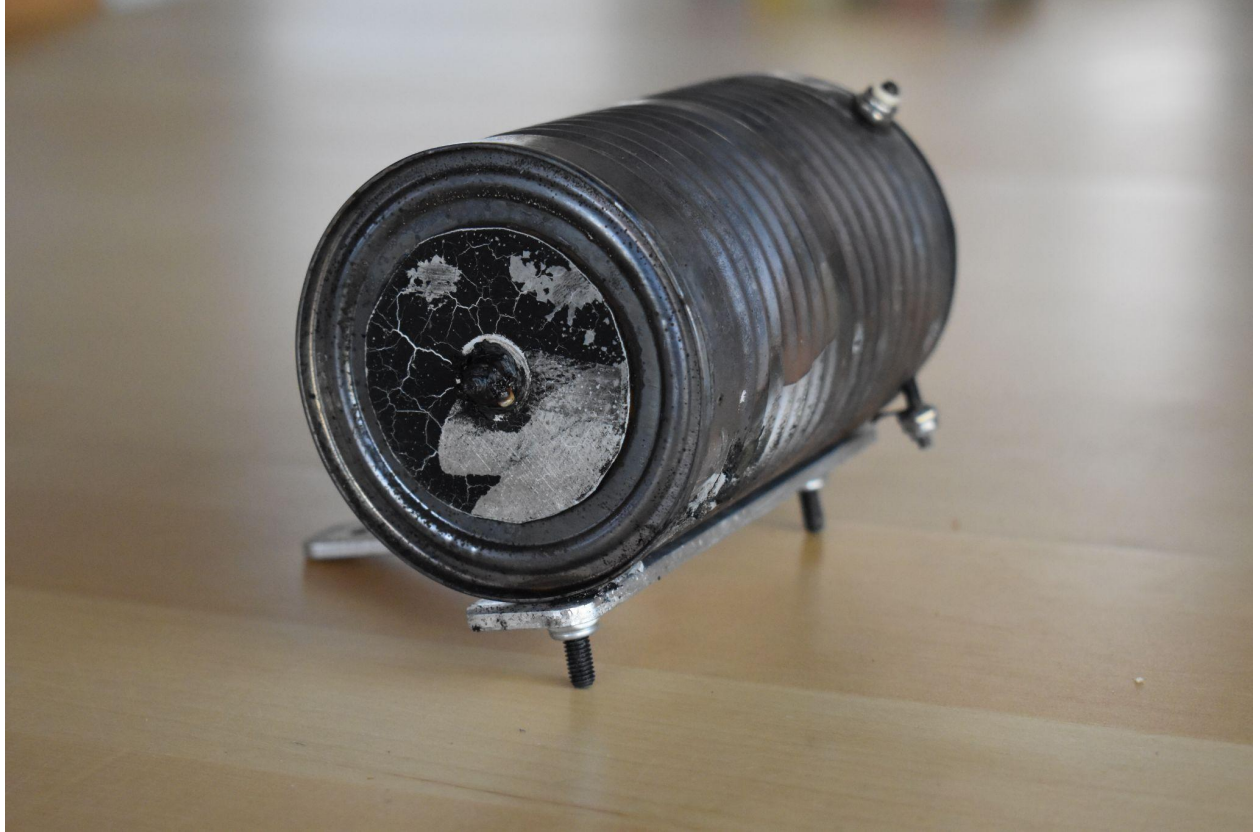
Front right view of Prototype 1 following testing.

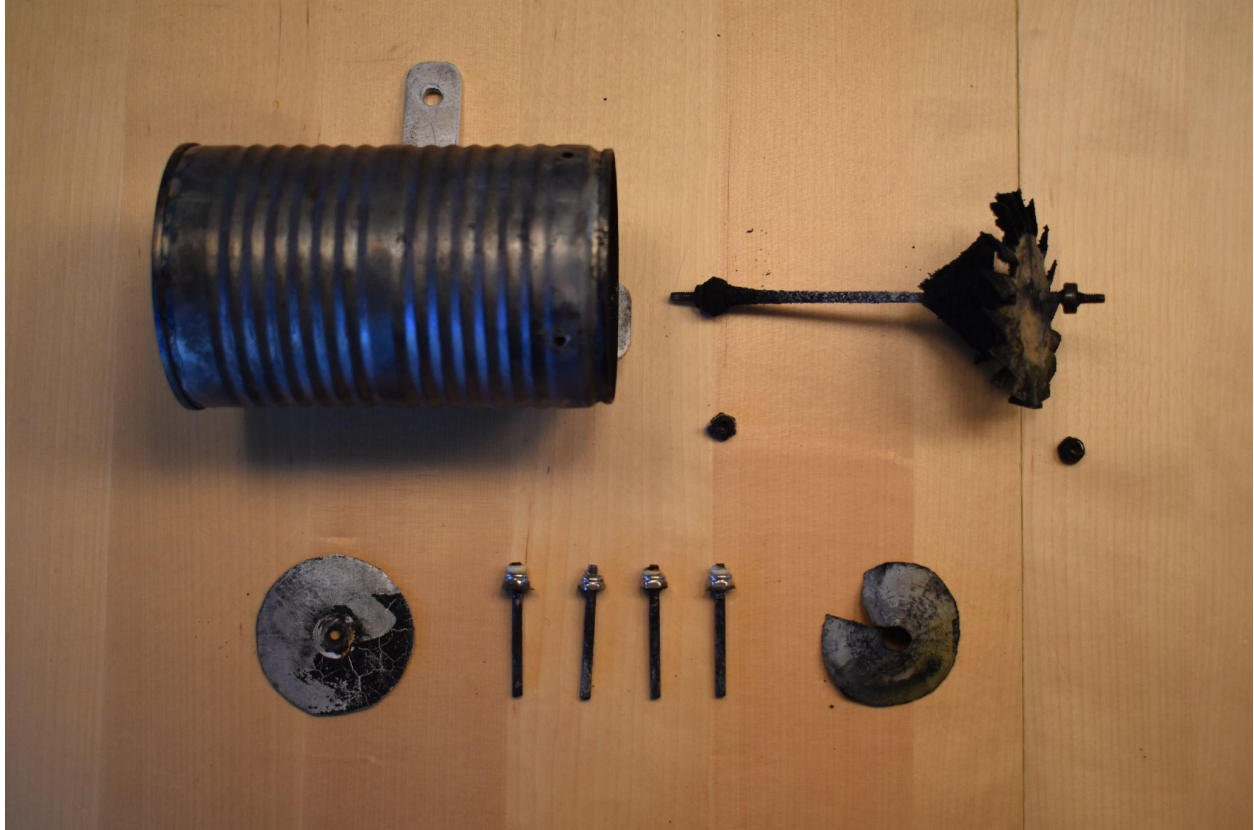
Dismantled Prototype 1 and internal components laid out for post-experiment analysis.

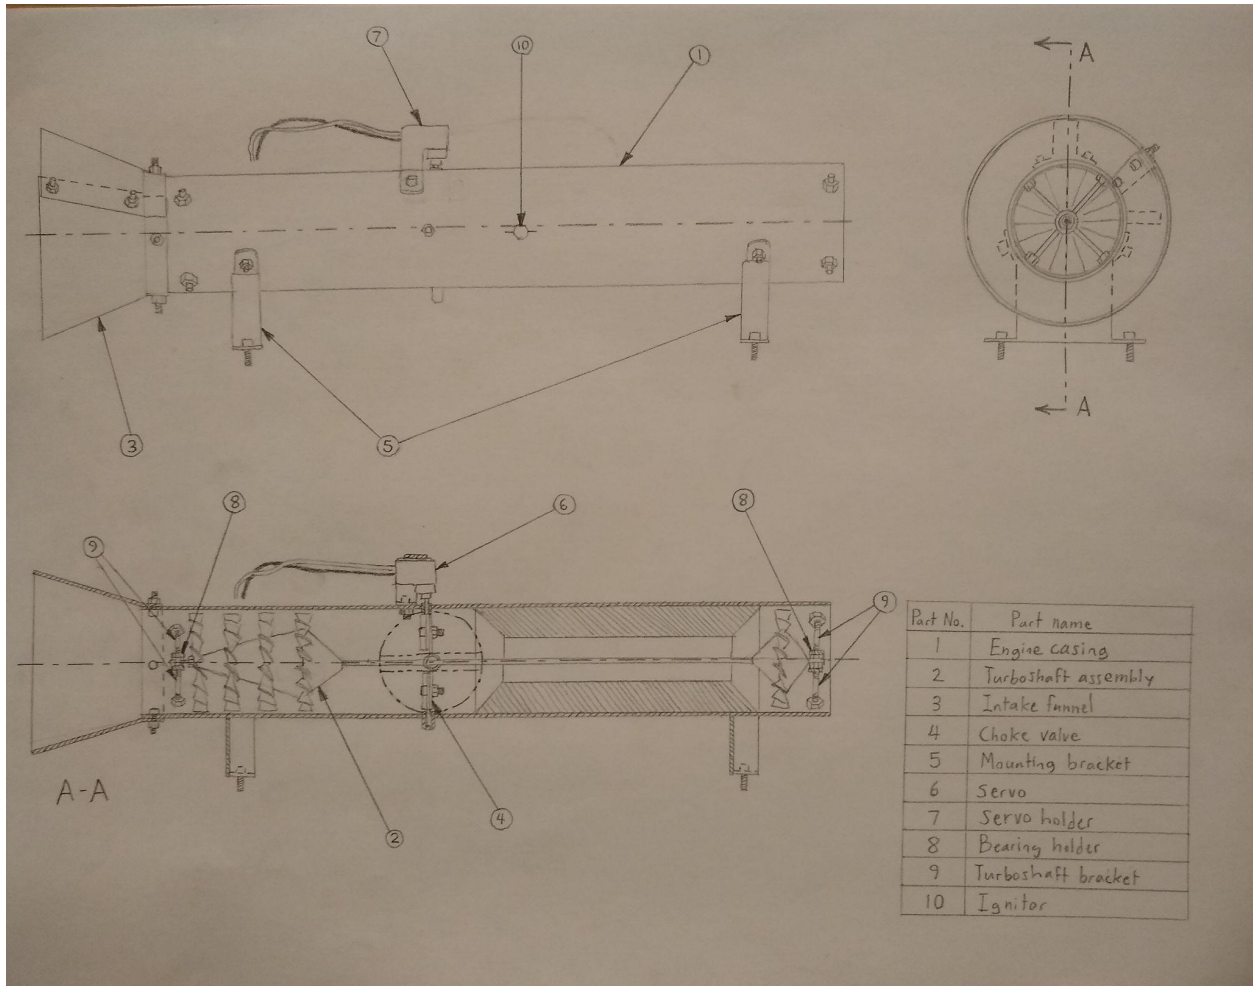
Assembly diagram of revised DAST engine design derived from collected data.
